# AEROSPACE INFORMATION REPORT

## AIR 764A

### SKID CONTROL SYSTEM VIBRATION SURVEY

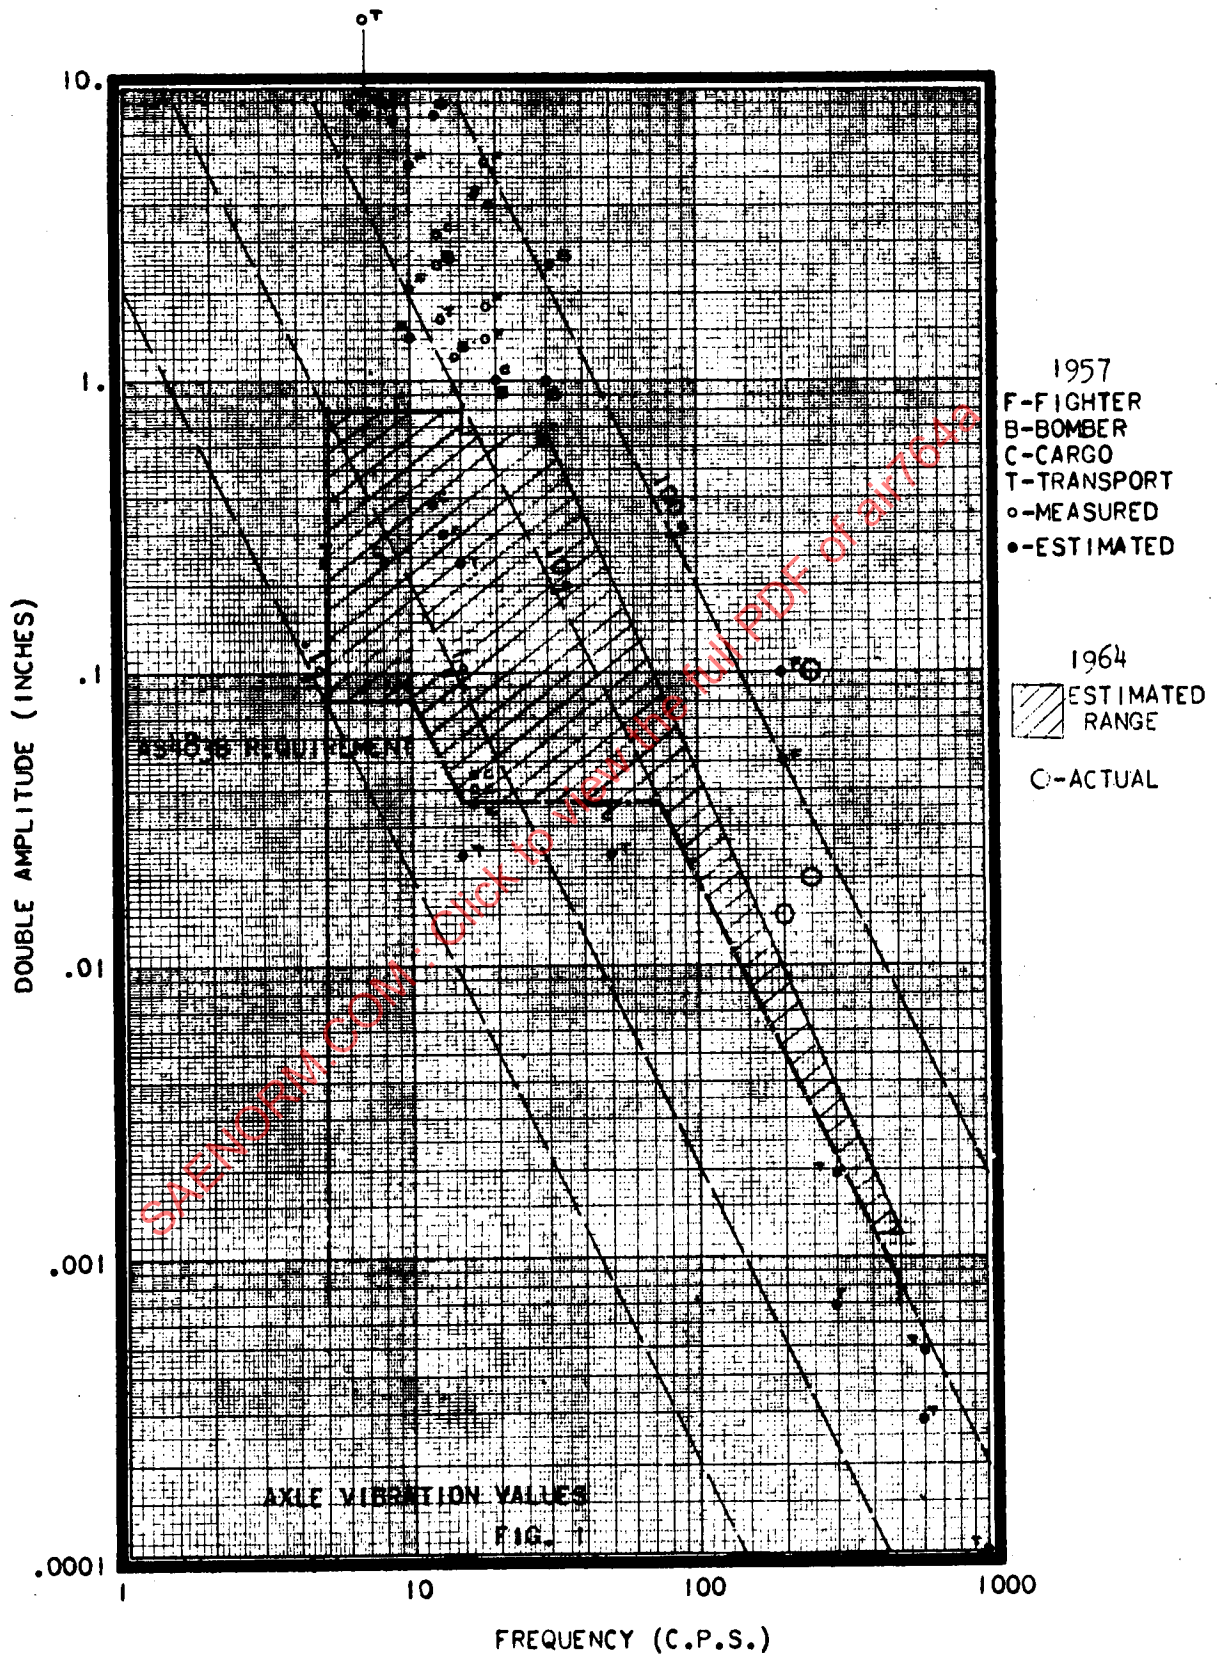
The reported values are plotted on Figures 1 and 2 showing the comparison of these values with the AS 483B vibration requirements.

This information has been added to Figures 1 and 2 as noted in the figure margins.
